Garden Decking Photos, Plans, & Ideas

Shaped Split-Level Decking

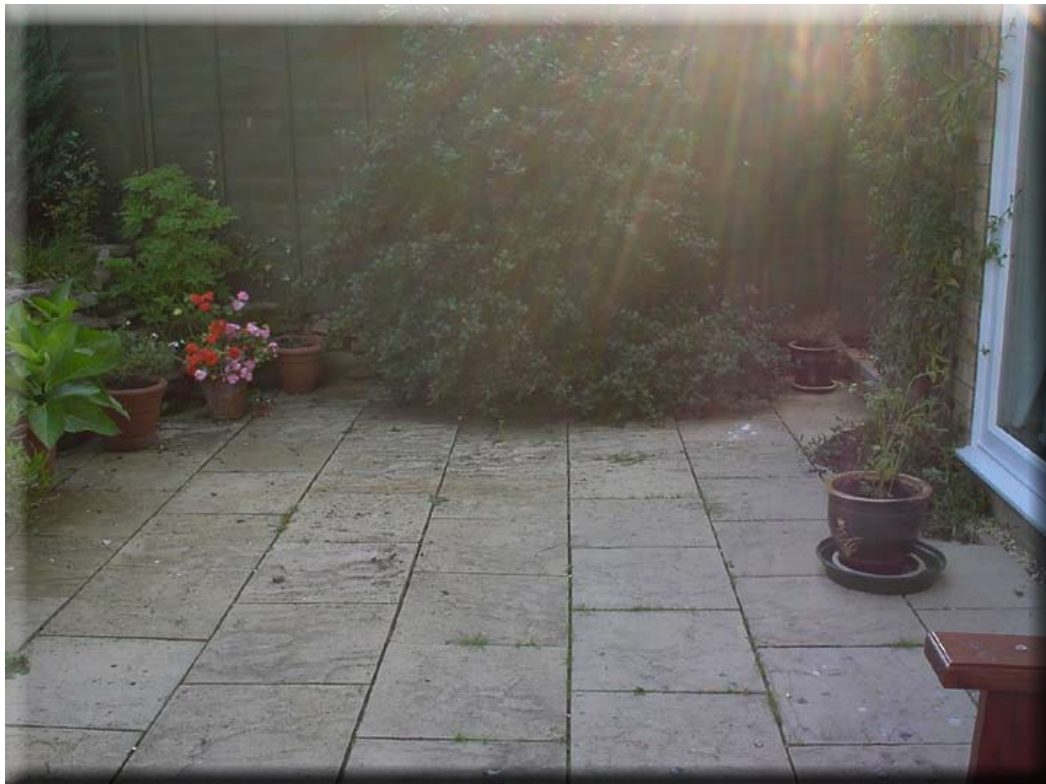
Old Slabbed Patio

This garden was typical of one designed ten years earlier, and now really needs major re-model.

The original features of the garden include a small stone wall (just to the left in the above photo) and a large raised lawn area accessed by stone steps from the patio.

The concrete slabs provide a pleasant place to entertain but require constant weeding, and although they remain fairly level you can see they allow water to collect and create messy puddles.

There is also an uncomfortable step from the house down to the patio level, and this can create a hazard.

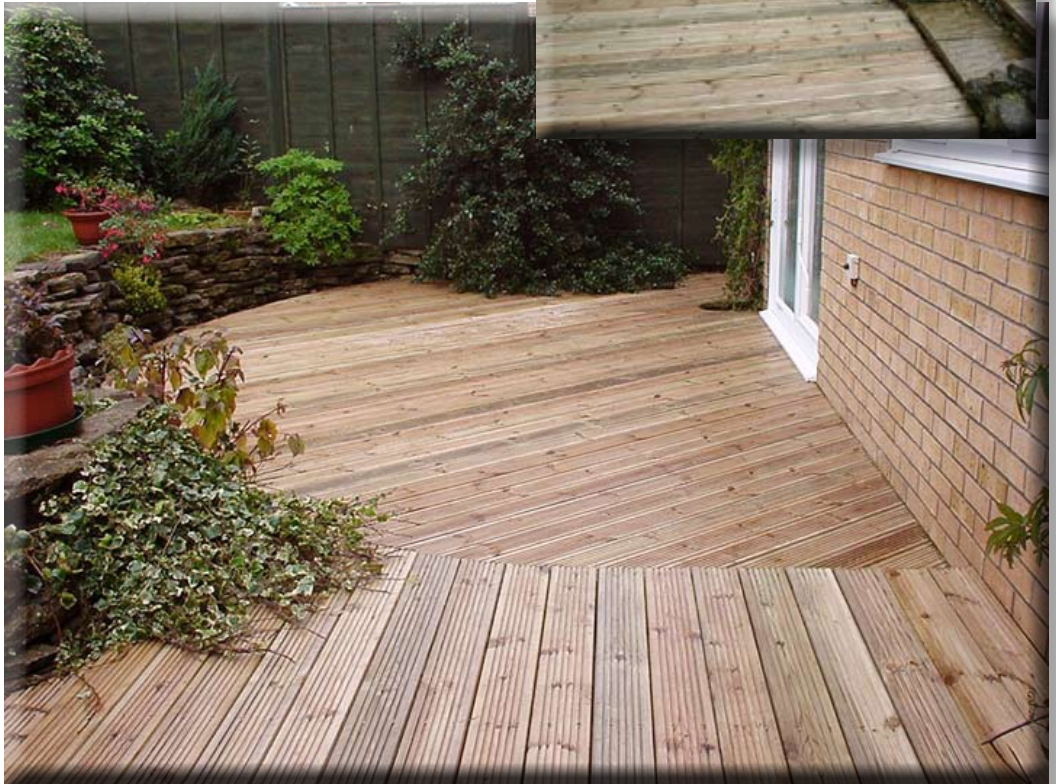
To enhance the existing features, the decking was designed in a curve, encompassing the dry stone wall and sweeping all the way back to join the house. The decking boards on the lower area are laid at 45 degrees and lead the eye from the French doors to the stone steps and the lawns.

The boards on the second area of decking are laid in a contrasting direction, and emphasises the fact that it is on a different level.

All the existing plants were left in the ground and planting holes were built into the decking to enable each plant to get ample water to its roots.
